Repair of Oil Pipes on the FPSO Crystal Ocean

Case Studies

PROJECT: Repair of Oil Pipes on the FPSO Crystal Ocean

PRODUCT: Auspreg UV MTT 958 VE

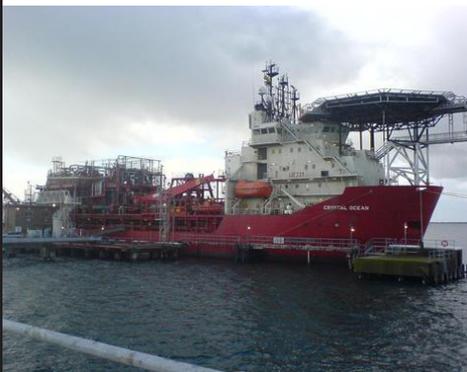
OVERVIEW: Reduced wall thickness was reported in the 8" diameter slug catcher elbow and weld outlet pipes aboard the floating production, storage and offloading oil vessel – "FPSO Crystal Ocean". A rapid temporary repair solution with minimal downtime was required to enable the continued flow of oil through the pipes at 90 bar pressure until brand new replacement parts could be sourced and installed 2 weeks later.

Engineering crews temporarily diverted oil flow so the compromised parts could be taken off. They were then wire brushed to remove paint and solvent cleaned. In a darkened part of the vessel, 10 cm strips of Auspreg™ UV cure Vinylester prepreg were cut and applied in overlapping strips two layers thick. A heat shrink film was then wrapped around the prepreg and heat shrunk using a hand held heat gun to ensure that the prepreg adhered to the metal surface and bonded well between the layers. The parts were then exposed to 30 minutes of sunlight. Once cured, the elbow and weld outlets were painted and reconnected. In total 25 parts with reduced wall thickness were reinforced with Auspreg™
